Case Study

# Identifying External Interference at Co-Located Cell Sites

Complex Intermodulation Caused Poor Uplink RSSI

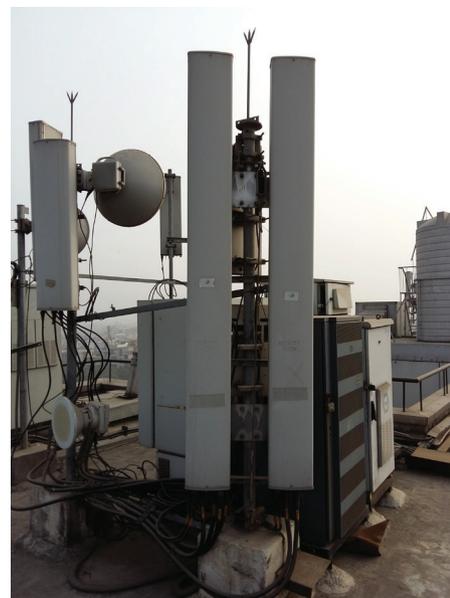
Figure 1: Co-located rooftop cell site

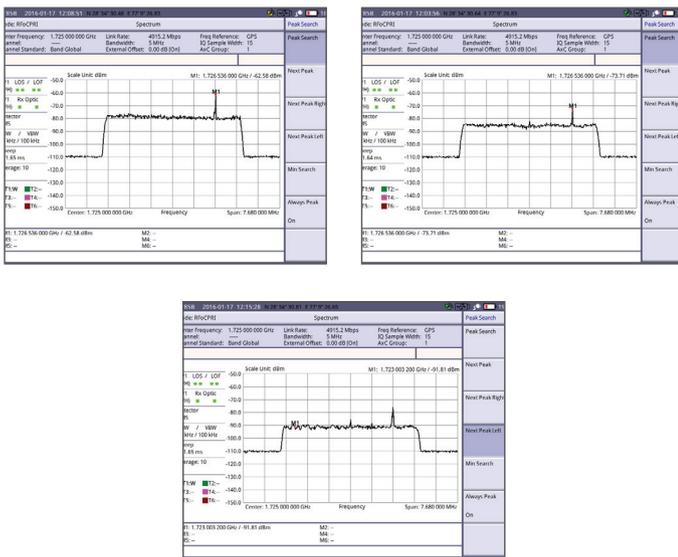
The site under investigation was a rooftop site with fiber to the antenna (FTTA) cell-site configuration. Using CellAdvisor™ with RFoCPRI, the team was able to see similar signal peaks on all three sectors, with variable intensity/strength indicating the presence of external interference that was affecting the whole site. However, the Alpha sector reported the highest signal from the interference source. This test confirmed what the operator was seeing at the LTE System Management Radio (LSM-R) interface. The next step was to identify the source of external interference.

Figure 2: External interference seen on all three sectors

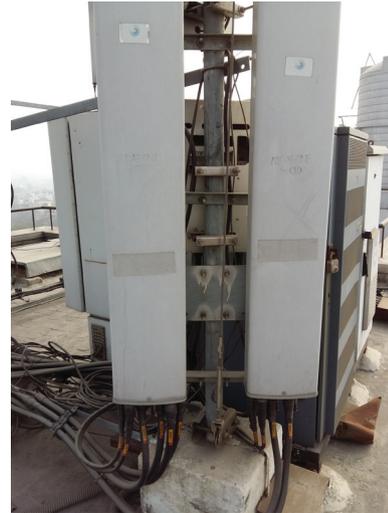
After performing multiple scans, it appeared that RSSI on UL was maxing near another operator's antenna. Technically, there should not have been any RF energy coming from that operator's antenna into the UL the team was investigating. However, a PIM issue at the other operator's antenna, and the proximity of the two antenna systems, was generating enough RF energy to desensitize the UL spectrum of the VIAVI customer.

Figure 3: PIM generating antenna

After some time, the other operator replaced the offending antenna, after which our team ran another RSSI scan and did not see the same noise floor increase after this change. Using the network based LSMR reports, the VIAVI customer also confirmed that the high RSSI on all three sectors of the cell site was eliminated.

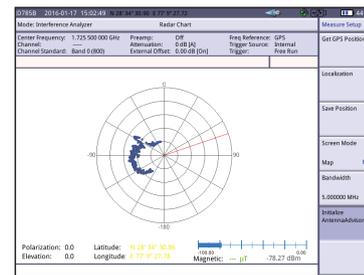
Using the AntennaAdvisor attachment along with the CellAdvisor, the team performed a 360-degree RSSI scan of the rooftop, paying close attention to the Alpha sector. Surprisingly, AntennaAdvisor did not show any peaks, but the team did observe a rise in RSSI noise floor when the AntennaAdvisor handle pointed in a certain direction. This observation really piqued the team's interest, and they decided to perform multiple RSSI scans with the AntennaAdvisor on that rooftop.

Figure 4: AntennaAdvisor indicating the presence of a strong interference signal in the UL
