Identifying and Locating Interference with CellAdvisor™

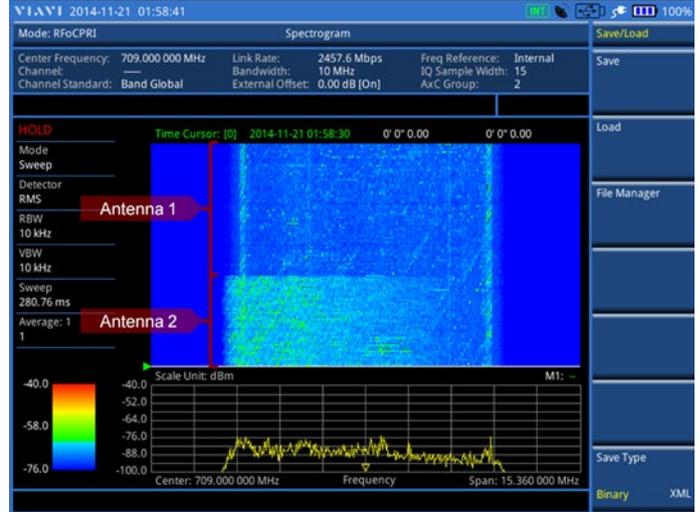
Spectrogram result showing a PIM issue on antenna 2

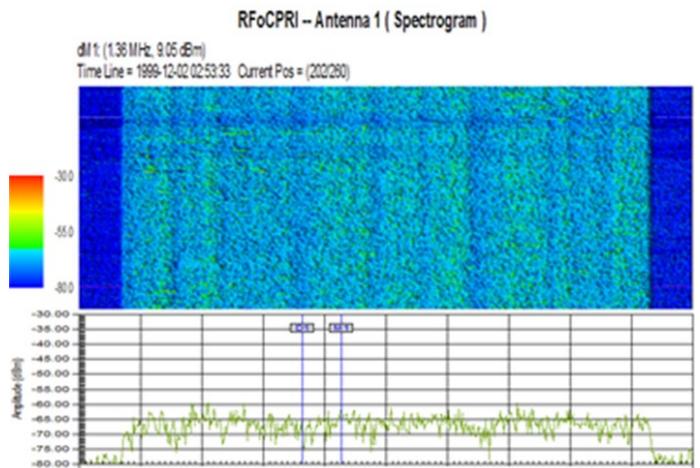
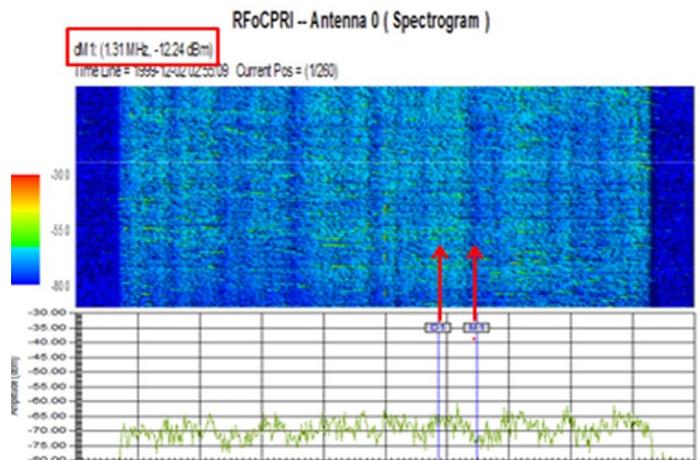
Comparative spectrogram results showing consistent interference on both antennas; note rolling rises in the noise floor across the whole band

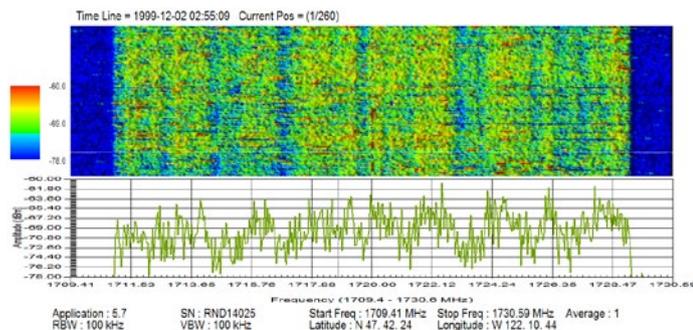
Technicians on the ground connected the Viavi Solutions™ CellAdvisor. It decoded RF information sent on the CPRI link from the RRH to the BBU and displayed those results in a traditional spectrum analyzer view. This clearly indicated that the uplink noise floor for that sector was higher than normal.

CellAdvisor RFOCPRI result displaying RRH uplink noise

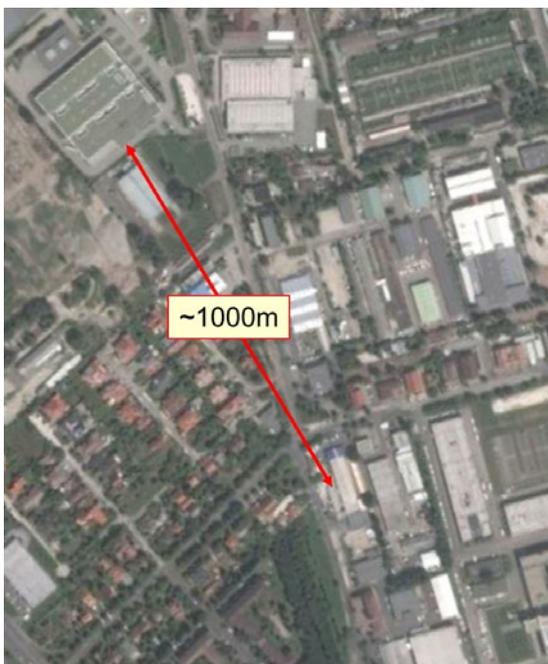
CellAdvisor™ is a powerful tool for detecting interference, significantly reducing the time it takes to identify issues. In this case, it identified external interference as the most likely culprit. Thereafter, just 3 hours of driving and walk-testing a nearby building identified the interference source: a misconfigured bi-directional amplifier located approximately 1,000 meters from the base station and unknown to the wireless service provider.

Source of interference
