Case Study

Identifying and Locating Interference with CellAdvisor

For several months, a tier 1 service provider experienced low, intermittent throughput issues at one their eNodeB sectors. Unable to identify the root cause, the provider replaced the RRH as well as fiber—to no avail. The performance issues continued.

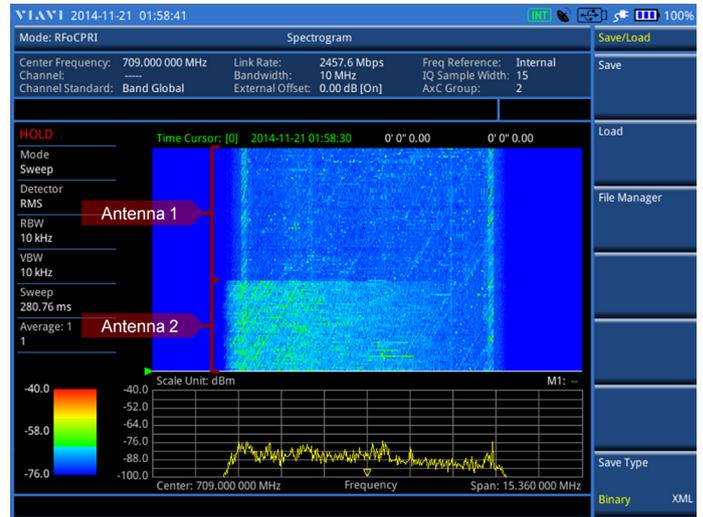
The cause of high uplink noise floors on remote radio heads (RRHs) can be either internal or external. Internal issues are often due to passive intermodulation (PIM) and, because most RRHs are inaccessible from the ground, repairing them is costly. In a typical PIM case, reviewing the spectrogram for abnormal noise levels will show a visible difference between two antenna measurements. In the case of external interference, both antenna links will show a noise rise.

Spectrogram result showing a PIM issue on antenna 2

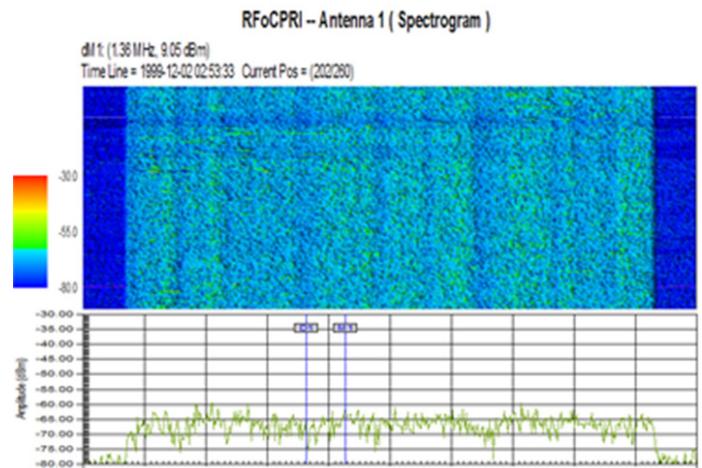
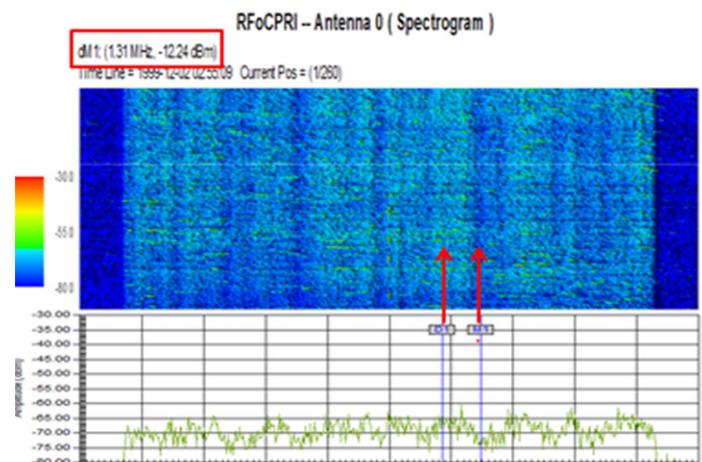
Comparative spectrogram results showing consistent interference on both antennas; note rolling rises in the noise floor across the whole band

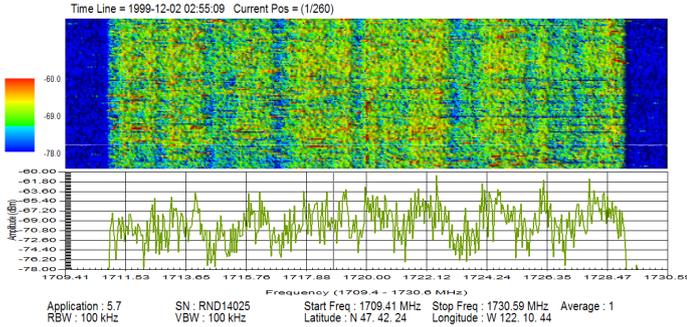
Technicians on the ground connected the VIAVI Solution CellAdvisor™. It decoded RF information sent on the CPRI link from the RRH to the BBU and displayed those results in a traditional spectrum analyzer view. This clearly indicated that the uplink noise floor for that sector was higher than normal.

CellAdvisor RFoCPRI result displaying RRH uplink noise

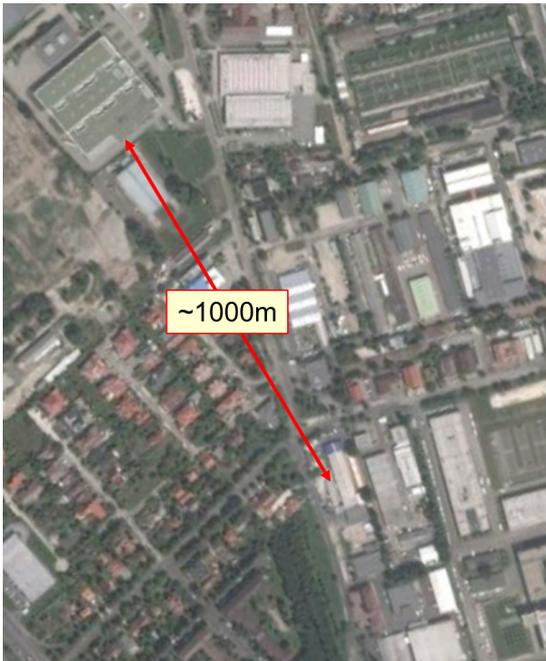
CellAdvisor is a powerful tool for detecting interference, significantly reducing the time it takes to identify issues. In this case, it identified external interference as the most likely culprit. Thereafter, just 3 hours of driving and walk-testing a nearby building identified the interference source: a misconfigured bi-directional amplifier located approximately 1,000 meters from the base station and unknown to the wireless service provider.

Source of interference
