Product Information Letter

AVX-10K Application Initialization Issue

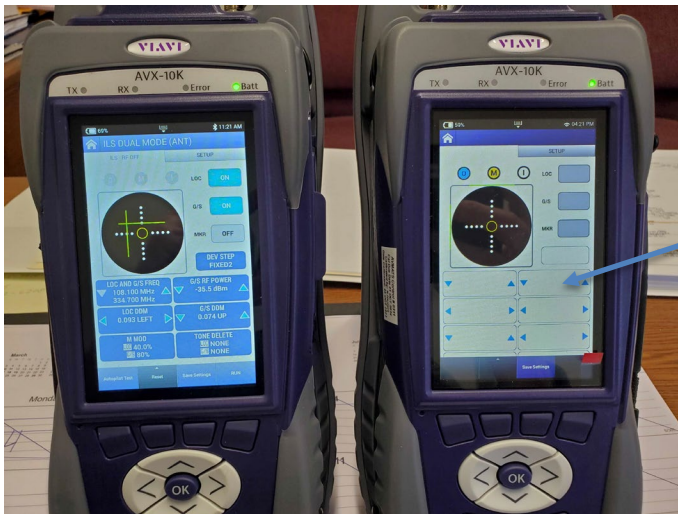
This Product Information Letter is to inform you of an issue with launching test applications that have been seen on a few units. This symptom is a lengthy initialization time resulting in the application data fields not populating, as shown here:

Data does not populate in the application data fields, as shown here.

Improvements have been made in software release 4.1.2 and above, but to fully correct this issue, a minor factory hardware modification is required. If your unit experiences this symptom, please contact customer care and request an [RMA](#) to receive this modification and a fresh calibration. If your unit is not experiencing this symptom, the modification will be performed on the next scheduled calibration. Performance is not affected by this issue.
