Identifying External Interference at Co-Located Cell Sites

Complex Intermodulation Caused Poor Uplink RSSI

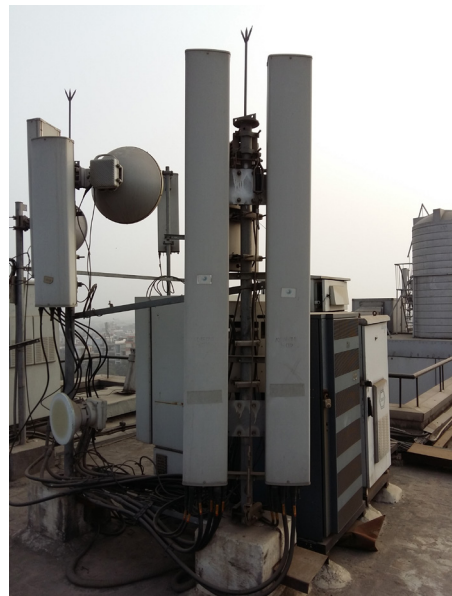
Figure 1: Co-located rooftop cell site

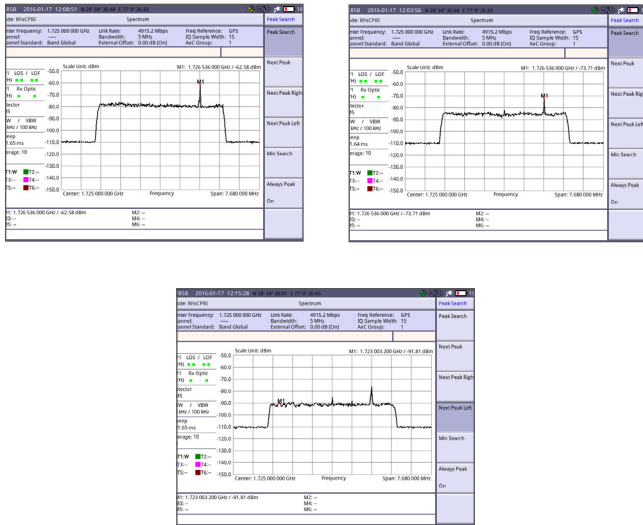
The site under investigation was a rooftop site with fiber to the antenna (FTTA) cell-site configuration. Using CellAdvisor™ with RFoCPRI, the team was able to see similar signal peaks on all three sectors, with variable intensity/strength indicating the presence of external interference that was affecting the whole site. However, the Alpha sector reported the highest signal from the interference source. This test confirmed what the operator was seeing at the LTE System Management Radio (LSM-R) interface. The next step was to identify the source of external interference.

Figure 2: External interference seen on all three sectors

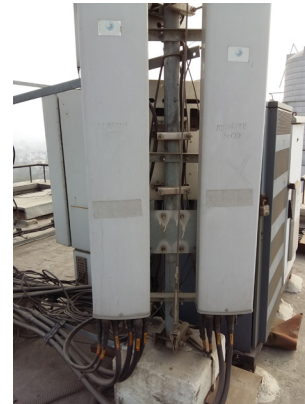
Using the AntennaAdvisor attachment along with the CellAdvisor, the team performed a 360-degree RSSI scan of the rooftop, paying close attention to the Alpha sector. Surprisingly, AntennaAdvisor did not show any peaks, but the team did observe a rise in RSSI noise floor when the AntennaAdvisor handle pointed in a certain direction. This observation really piqued the team's interest, and they decided to perform multiple RSSI scans with the AntennaAdvisor on that rooftop. After performing multiple scans, it appeared that RSSI on UL was maxing near another operator's antenna. Technically, there should not have been any RF energy coming from that operator's antenna into the UL the team was investigating. However, a PIM issue at the other operator's antenna, and the proximity of the two antenna systems, was generating enough RF energy to desensitize the UL spectrum of the Viavi customer.

Figure 3: PIM generating antenna

After some time, the other operator replaced the offending antenna, after which our team ran another RSSI scan and did not see the same noise floor increase after this change. Using the network based LSMR reports, the Viavi customer also confirmed that the high RSSI on all three sectors of the cell site was eliminated.
