Detecting Bridged Tap and Noise Interference in VDSL2 Access Networks using the JDSU SmartClass™ TPS

The JDSU SmartClass TPS tester is the ideal tool for technicians who install, troubleshoot, and maintain Triple-Play services.

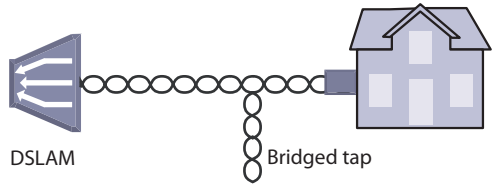
Figure 1. Bridged taps can impact DSL performance.

Copper Fault	Impact to DSL Service
Bridged taps	A bridged tap is every piece of wire not belonging to the main cable between the DSLAM and the customer premises equipment (CPE) modem. Bridged taps cause undesirable reflections at the splice point and at the end of the tap. The reflected signal becomes noise in the circuit that degrades DSL performance. Further, bridged taps can act as antennas and pick up external noise along the tap.
Poor pair balance	Twisted copper pair can cancel out some of the external noise caused by other DSL lines or short, intermittent impulse noise that electrical devices cause in the Home Network. However, if the pair is unbalanced, noise will bleed into the copper pair and degrade DSL performance.
Corroded contacts	Corroded contacts act as capacitive faults that especially impact the lower part of the frequency spectrum resulting in degraded DSL performance.

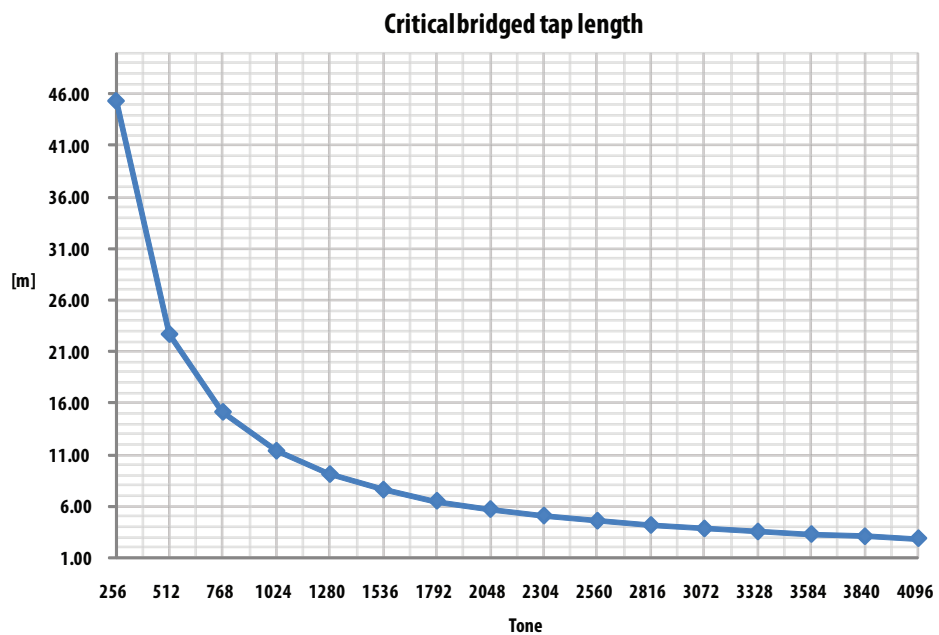
Table 1. Critical bridged tap lengths for a selection of transmission channels. *

*All examples are calculated with an assumed velocity of propagation (VoP) = 200,000 km/s.

Bridged taps will not affect all tones equally. A given bridged tap may impact some frequencies more than others. Table 1 shows the critical bridged tap length for a specific discrete multitone (DMT) tone that will impact DSL service.

The presence of bridged taps can be identified using the $H_{log}(f)$ data defined in ITU-T G.992.3 as the frequency response per channel with characteristic “valleys/dips” at tones that correspond to the bridged tap length shown in Table 1. This DELT-type measurement requires that the Digital Subscriber Line Access Multiplexer (DSLAM) and CPE modem be connected at both ends. As a simple illustration, the H_{log} typically represents the attenuation per power spectral density (PSD) carrier.

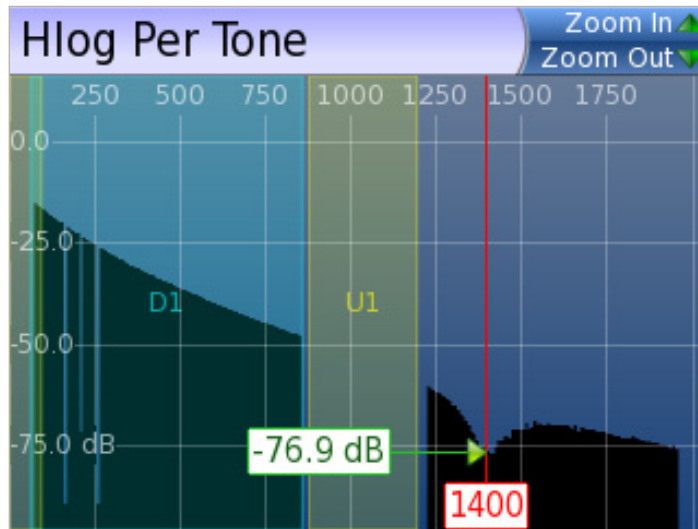
Figure 2. A bridged tap caused a "dip" on the Hlog frequency response curve. The example shows a bridged tap length of approximately 8 m.

Figure 2 shows an example of a dip on the Hlog graph at tone 1400 caused by a bridged tap. Figure 3 shows the Hlog graph after removing the approximately 8 m long bridged tap. A bridged tap similar to this one can easily degrade VDSL2 service by more than 2 Mbps.

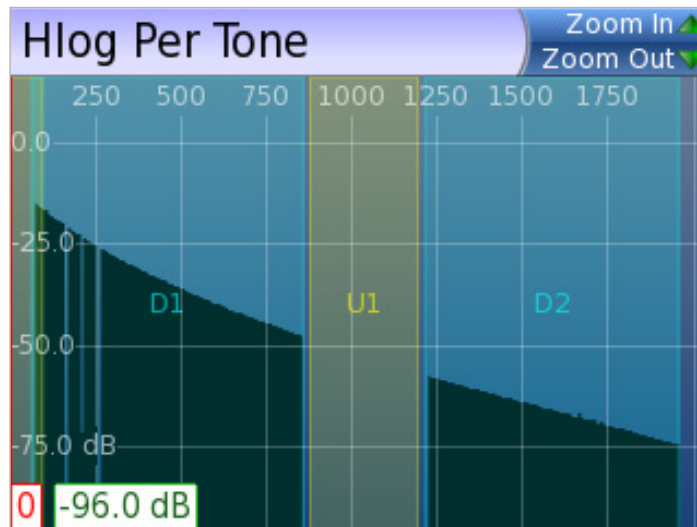
Figure 3. "Clean" frequency response after removing the bridged tap.

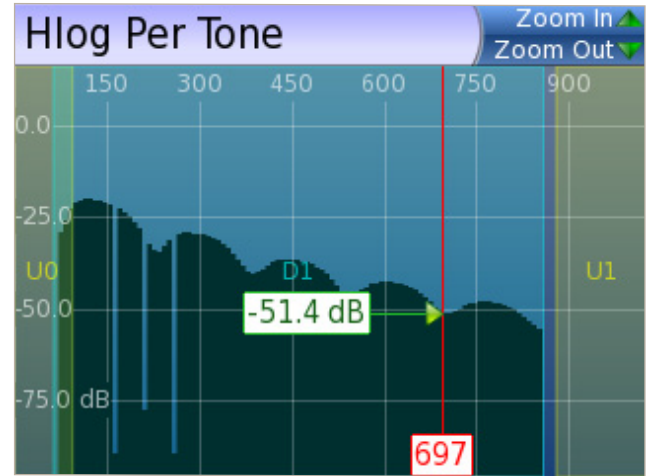
Figure 10. Hlog per tone graph, cursor at tone 697.

While Figure 7 showed regular ups and downs indicating the possible presence of a bridged tap, Figure 9 confirms the presence of a bridged tap as the Hlog per tone graph indicates. Either method can identify the first dip; refer to Table 1 to see the associated bridged tap length. Occasionally this is too difficult, see Figure 9 which uses Table 2. The Table 2 method takes two dips and counts the sub-dips to identify the bridged tap length. For Figures 9 and 10, the tone delta is 310 tones with one sub-dip in between and using Table 2 provides an approximate bridged tap length of 150 m. This bridged tap can be identified and removed, thus showing an Hlog response similar to the one shown in Figure 3. Figure 11 shows that the DSL Maximum Rate improved by approximately 8 Mbps and the Connection Rate is back to the contract planned 25 Mbps service.
