# Detecting Bridged Tap and Noise Interference in VDSL2 Access Networks using the JDSU SmartClass™ TPS

The JDSU SmartClass TPS tester is the ideal tool for technicians who install, troubleshoot, and maintain Triple-Play services.

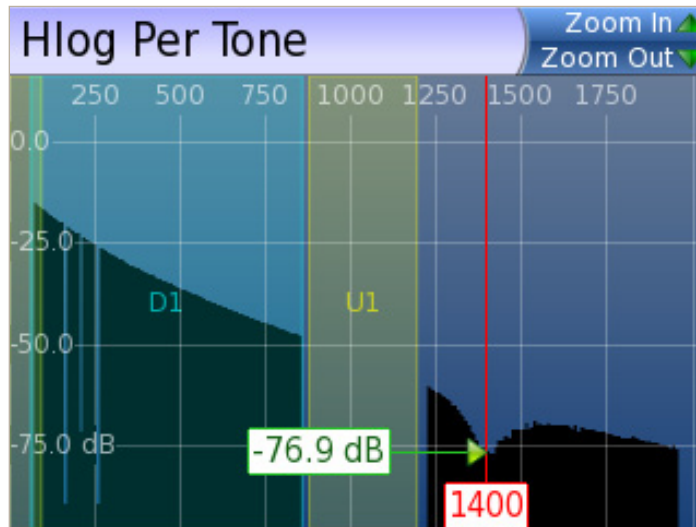
Figure 2. A bridged tap caused a “dip” on the Hlog frequency response curve. The example shows a bridged tap length of approximately 8 m.

Figure 2 shows an example of a dip on the Hlog graph at tone 1400 caused by a bridged tap. Figure 3 shows the Hlog graph after removing the approximately 8 m long bridged tap. A bridged tap similar to this one can easily degrade VDSL2 service by more than 2 Mbps.

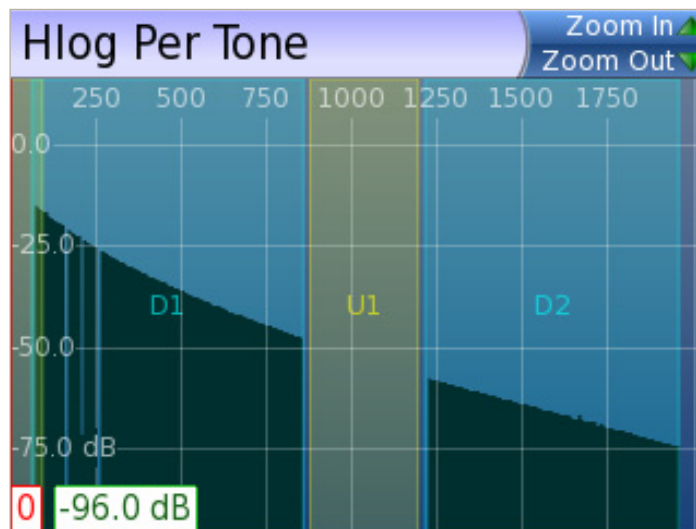
Figure 3. “Clean” frequency response after removing the bridged tap.
