Detecting Bridged Tap and Noise Interference in VDSL2 Access Networks using the JDSU SmartClass™ TPS

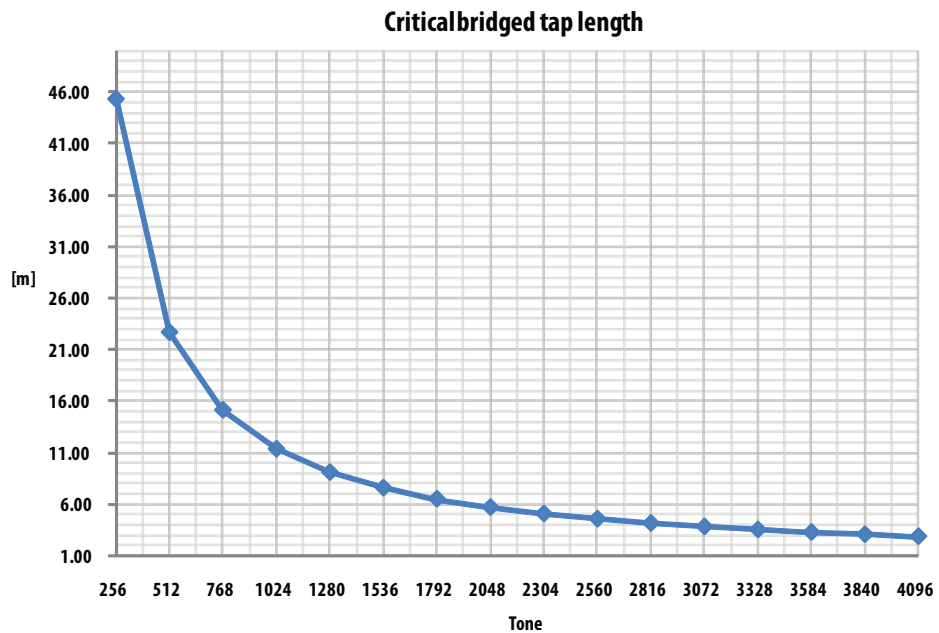
Table 1. Critical bridged tap lengths for a selection of transmission channels. *

Bridged taps will not affect all tones equally. A given bridged tap may impact some frequencies more than others. Table 1 shows the critical bridged tap length for a specific discrete multitone (DMT) tone that will impact DSL service.

*All examples are calculated with an assumed velocity of propagation (VoP) = 200,000 km/s.

The presence of bridged taps can be identified using the $H_{log}(f)$ data defined in ITU-T G.992.3 as the frequency response per channel with characteristic “valleys/dips” at tones that correspond to the bridged tap length shown in Table 1. This DELT-type measurement requires that the Digital Subscriber Line Access Multiplexer (DSLAM) and CPE modem be connected at both ends. As a simple illustration, the H_{log} typically represents the attenuation per power spectral density (PSD) carrier.

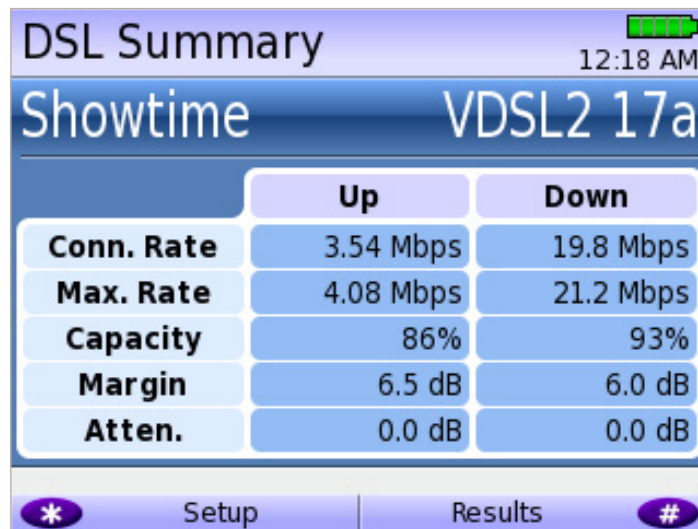
Figure 5. DSL Summary Results using the SmartClass TPS.

All DSL testing associated with installation and repair must start by connecting the SmartClass TPS to the line and verifying the DSL performance parameters against the provisioned Connection Rates, as shown in Figures 4 and 5.
