Case Study

Detecting and Identifying Uplink Interference with CellAdvisor

Reducing tower climbs in the Himalayas saves time and increases safety

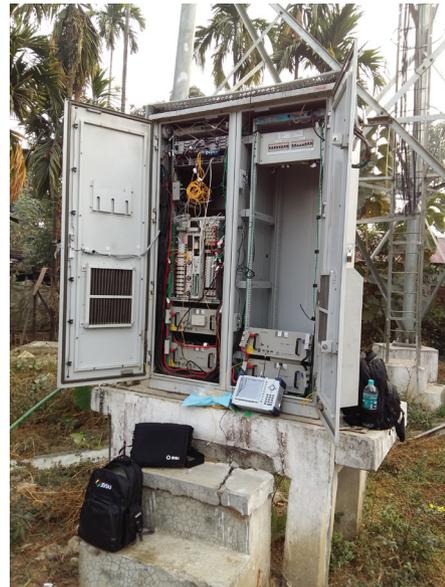
CellAdvisor tapping the BBU-RRH CPRI link — all measurements are at ground level

To avoid dangerous tower climbs, the CellAdvisor RFoCPRI feature enabled, connecting CellAdvisor to Uplink CPRI cables, by tapping UL CPRI fibre, at BBU ground level. One interfering source turned out to be nearby radar beacon signals that had not migrated to a different allocated frequency. Interestingly, the interference was undetectable at ground level, and could only be recorded at antenna height. Other interference came from far-away Nepalese towers, presumably transmitting WiMAX in the 2310-2315 MHz band.

Another vital benefit was avoiding tower climbs by monitoring the uplink spectrum from the ground with RFoCPRI.

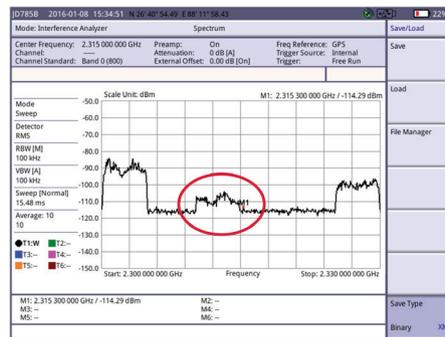
Interference observed at nearby rooftop
