Detecting Bridged Tap and Noise Interference in VDSL2 Access Networks using the JDSU SmartClass™ TPS

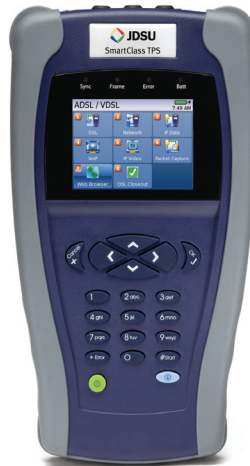
The JDSU SmartClass TPS tester is the ideal tool for technicians who install, troubleshoot, and maintain Triple-Play services.

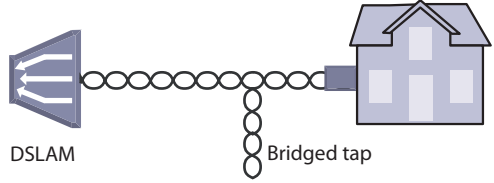
Figure 1. Bridged taps can impact DSL performance.

Copper Fault	Impact to DSL Service
Bridged taps	A bridged tap is every piece of wire not belonging to the main cable between the DSLAM and the customer premises equipment (CPE) modem. Bridged taps cause undesirable reflections at the splice point and at the end of the tap. The reflected signal becomes noise in the circuit that degrades DSL performance. Further, bridged taps can act as antennas and pick up external noise along the tap.
Poor pair balance	Twisted copper pair can cancel out some of the external noise caused by other DSL lines or short, intermittent impulse noise that electrical devices cause in the Home Network. However, if the pair is unbalanced, noise will bleed into the copper pair and degrade DSL performance.
Corroded contacts	Corroded contacts act as capacitive faults that especially impact the lower part of the frequency spectrum resulting in degraded DSL performance.

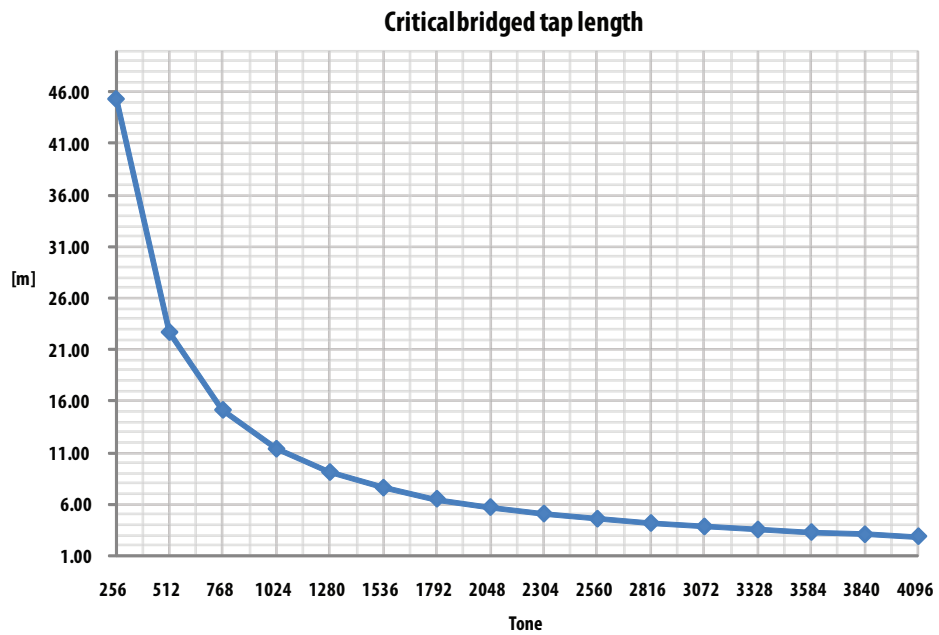
Bridged taps will not affect all tones equally. A given bridged tap may impact some frequencies more than others. Table 1 shows the critical bridged tap length for a specific discrete multitone (DMT) tone that will impact DSL service.

Table 1. Critical bridged tap lengths for a selection of transmission channels. *

The presence of bridged taps can be identified using the $H_{log}(f)$ data defined in ITU-T G.992.3 as the frequency response per channel with characteristic “valleys/dips” at tones that correspond to the bridged tap length shown in Table 1. This DELT-type measurement requires that the Digital Subscriber Line Access Multiplexer (DSLAM) and CPE modem be connected at both ends. As a simple illustration, the H_{log} typically represents the attenuation per power spectral density (PSD) carrier.

*All examples are calculated with an assumed velocity of propagation (VoP) = 200,000 km/s.

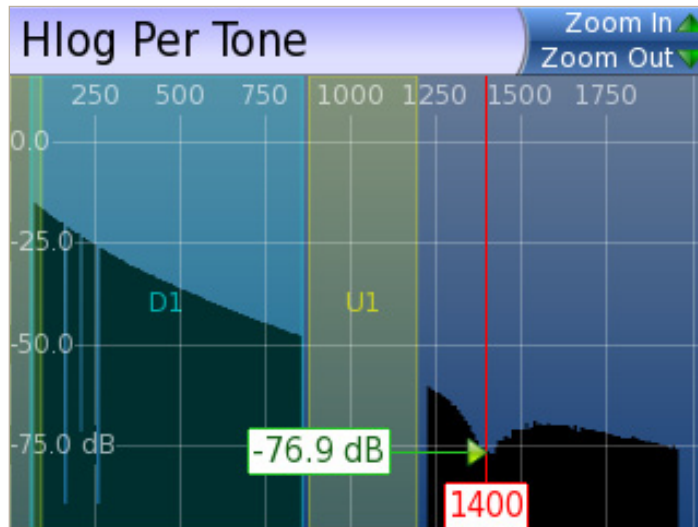
Figure 2 shows an example of a dip on the Hlog graph at tone 1400 caused by a bridged tap. Figure 3 shows the Hlog graph after removing the approximately 8 m long bridged tap. A bridged tap similar to this one can easily degrade VDSL2 service by more than 2 Mbps.

Figure 2. A bridged tap caused a "dip" on the Hlog frequency response curve. The example shows a bridged tap length of approximately 8 m.

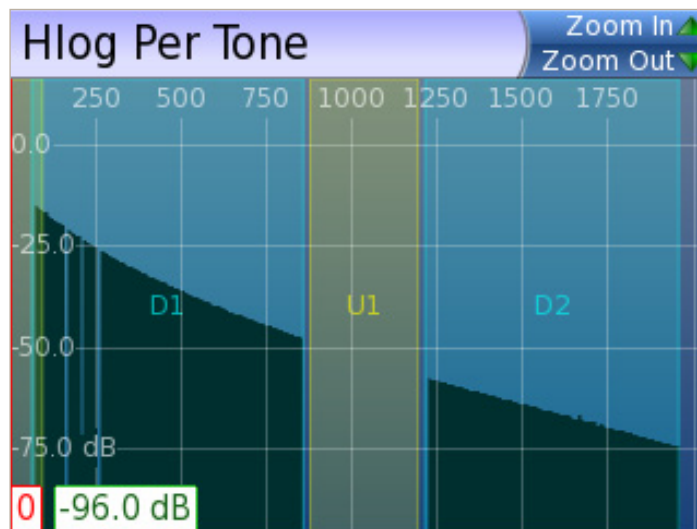
Figure 3. "Clean" frequency response after removing the bridged tap.

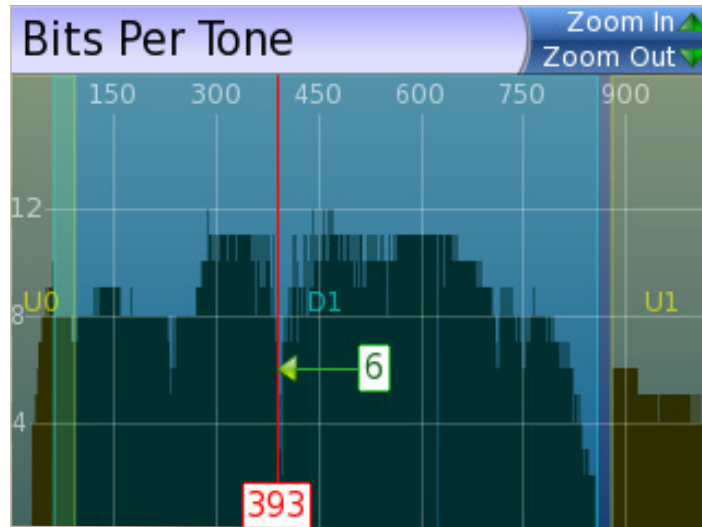
In the second step, technicians should review the bits per tone data, as shown in Figure 6, which concentrates the analysis on issues impacting the actual DSL line profile. A maximum of 15 bits can be carried over one tone. Similar to Figure 6, the bits-per-tone (BPT) graph can identify noise interference with a degraded bit load.

Figure 6. BPT analysis with degraded bit load around tone 393 due to possible noise interference.

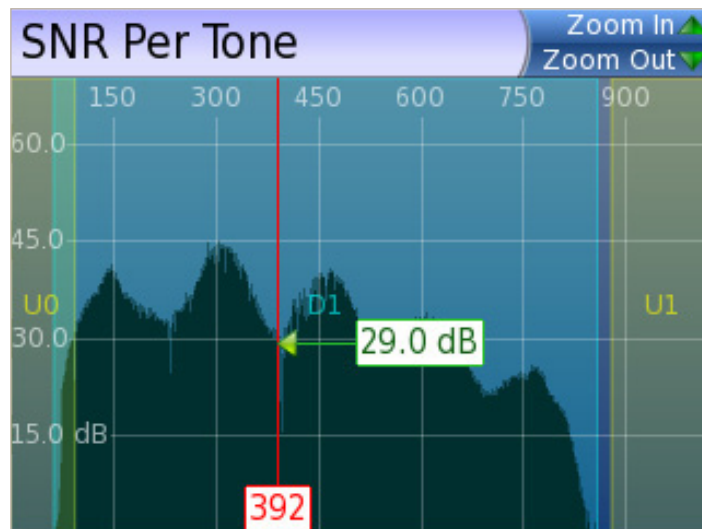
The next step is investigating the signal-to-noise ratio (SNR) per tone graph, as Figure 7 shows. This test can confirm possible noise interferers and may show that a possible bridged tap is causing the up and down patterns.

Figure 7. SNR per tone graph.

While Figure 7 showed regular ups and downs indicating the possible presence of a bridged tap, Figure 9 confirms the presence of a bridged tap as the Hlog per tone graph indicates. Either method can identify the first dip; refer to Table 1 to see the associated bridged tap length. Occasionally this is too difficult, see Figure 9 which uses Table 2. The Table 2 method takes two dips and counts the sub-dips to identify the bridged tap length. For Figures 9 and 10, the tone delta is 310 tones with one sub-dip in between and using Table 2 provides an approximate bridged tap length of 150 m. This bridged tap can be identified and removed, thus showing an Hlog response similar to the one shown in Figure 3. Figure 11 shows that the DSL Maximum Rate improved by approximately 8 Mbps and the Connection Rate is back to the contract planned 25 Mbps service.

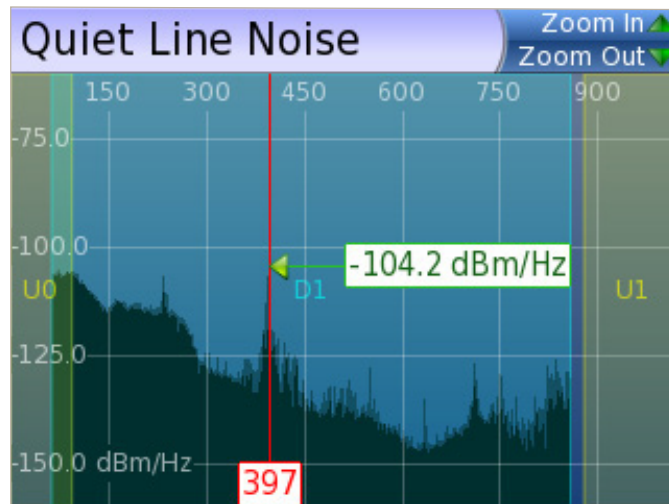
In order to differentiate between noise and bridged-tap-related impacts to the SNR and, therefore, the BPT load, technicians must review the Quiet Line Noise data that the SmartClass TPS provides, which is illustrated in Figure 8. Areas that show a sharply degraded BPT and SNR graph with an increased Quiet Line Noise value indicates noise interference issues. Figure 8 provides an example of a noise spike where the tones are around 397 and the lower part of the D1 band up to tone 290 as well the upper part of the D1 band around tone 800.

Figure 8. Quiet line noise that spikes at tone 397 and has a fairly high noise floor up to tone 290 and in the upper part of the D1 band.**

**The presence of a bridged tap might gain the noise interference as the bridged tap acts like an antenna.

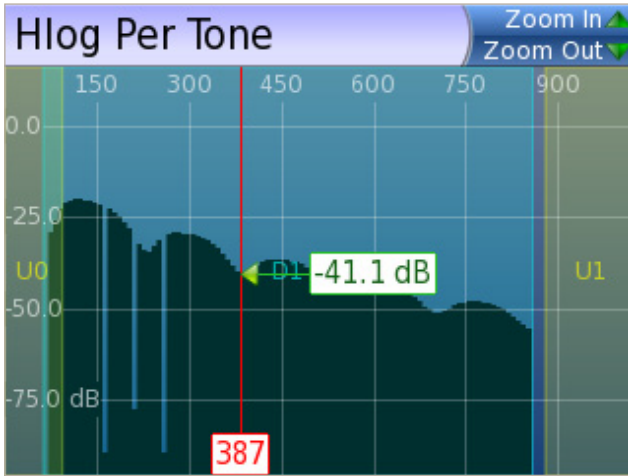
Figure 9. Hlog per tone graph, cursor at tone 387.

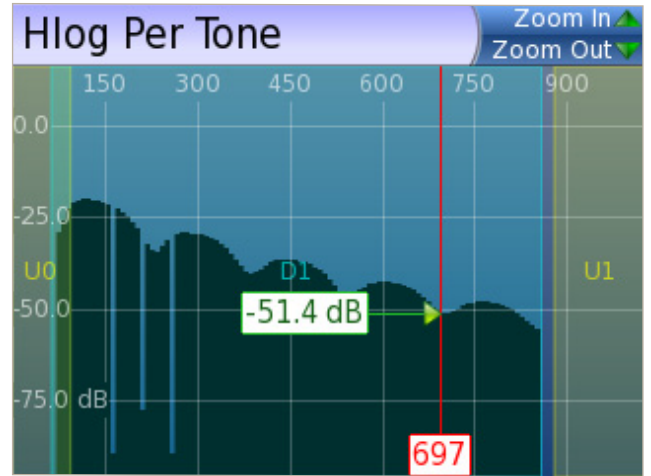
Figure 10. Hlog per tone graph, cursor at tone 697.

Bridged tap length in [m] for a given tone delta between two dips and number of sub-dips

Table 2. Bridged tap length in [m] using two “dips” and a defined number of “sub-dips”.

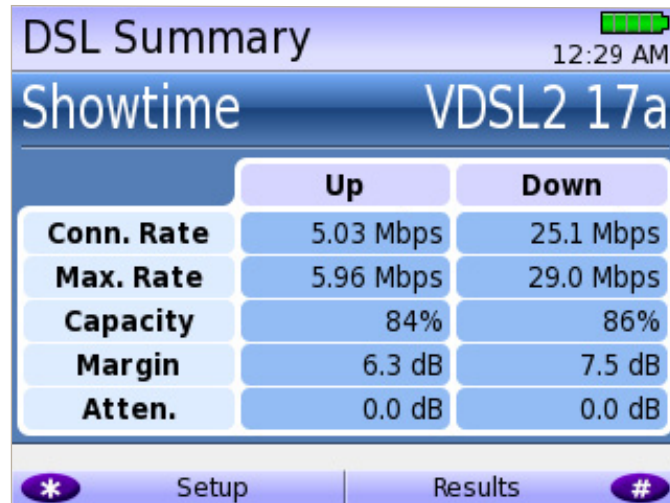
Figure 11. DSL Connection and Maximum Rates without the bridged tap.
