Troubleshooting Interference Issues during Radio Head Deployments with CellAdvisor™

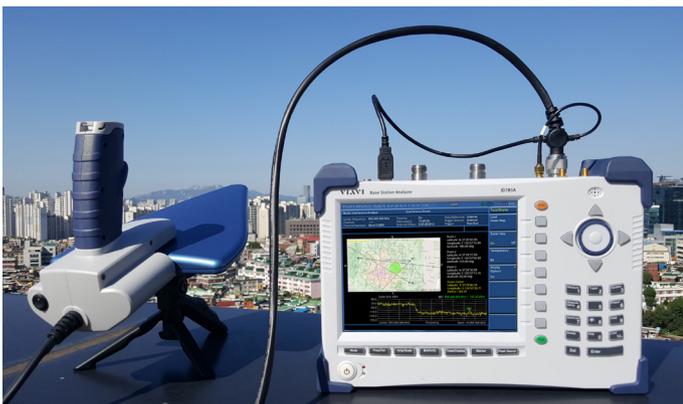
The CellAdvisor spectrum analyzer function significantly reduces the time it takes to identify interference issues. Using this function with the CellAdvisor JD785B and a directional Yagi antenna, an engineer was quickly able to identify interference on the uplink: it was seen across the 10 MHz LTE spectrum in use.

To meet trial deadlines, the Viavi NEM partner was not able to remove the source of interference. Instead, they used CellAdvisor measurements to relocate the radio head. Consequent measurements indicated a reduced level of interference near the new location. The radio was brought back in service. This let our NEM partner complete their customer proof-of-concept in a timely manner.

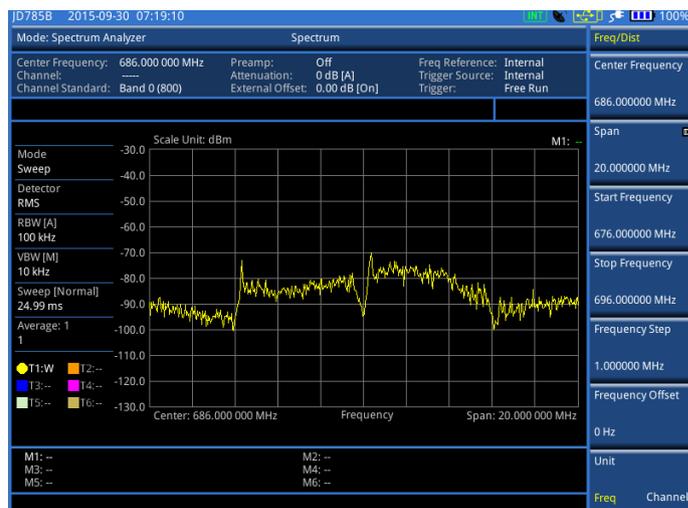
- It enables spectrum clearance, capturing just the events where the received signal exceeds the defined power limit
- The audible tone volume is proportional to the signal's power strength, and a built-in AM/FM audio demodulator conveniently identifies AM/FM signals
- Interference ID automatically classifies interfering signals and lists the possible signal types corresponding to the signal selected
- The Spectrogram feature captures spectrum activity over time and uses various colors to differentiate spectrum power levels
- Spectrogram is also effective for identifying periodic or intermittent signals, and post-processing analyzes each measurement over time using a time cursor
