Case Study

Zeroing in on an Interference Source with VIAVI InterferenceAdvisor and AntennaAdvisor

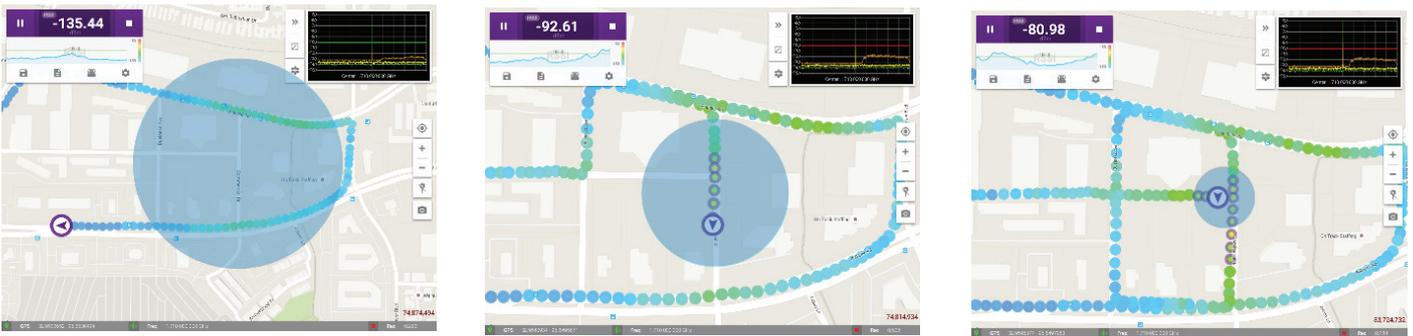
In less than an hour of driving with InterferenceAdvisor, the team narrowed the source area down to the block across from the Bridgestone Arena itself. The interfering signal was coming in hot at around -50dBm

A drive with EagleEye software indicates the strongest interference area.

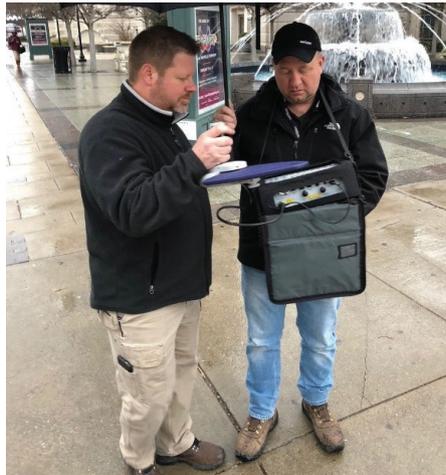
Pinpointing the source with AntennaAdvisor

Using the directional antenna with the Radar Chart option, the team was vectored across the parking lot toward a two-story brick building. As the team approached the building, the signal strength got hotter and hotter, into the -30's, then -20's, and even the teens! The back wall of the building was all brick, with no visible windows. There were no visible antennas on the roof or sides of the building. There were a couple of security cameras mounted between the first and second stories aimed toward the back alley.

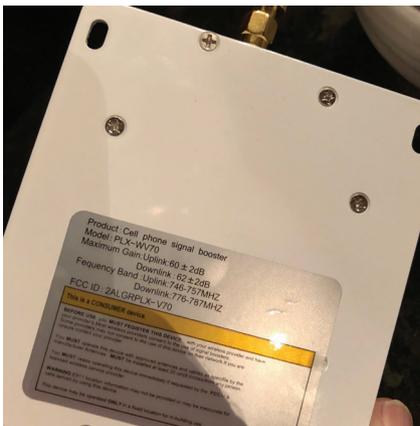
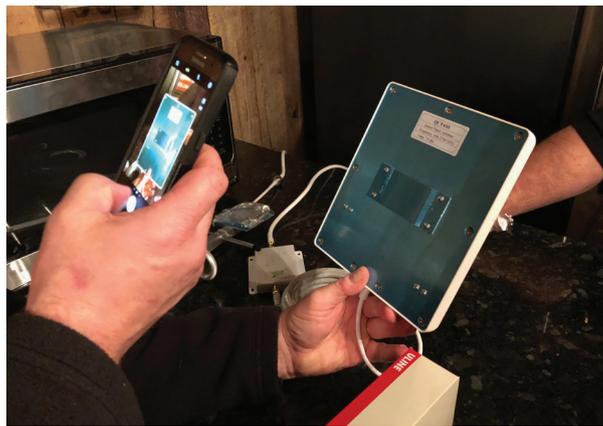
The team went to the building's entrance and spoke to the IT manager. He confirmed that he had recently installed a wireless repeater, purchased online, to boost RF signal in a back office.

Repeater that caused the interference

After the repeater was shut down, the team used VIAVI CellAdvisor and verified that that the rogue signal was gone.
