Case Study

# Finding the Cause of Interference Affecting an LTE Physical Resource Block

TV signal booster caused high RSSI problems

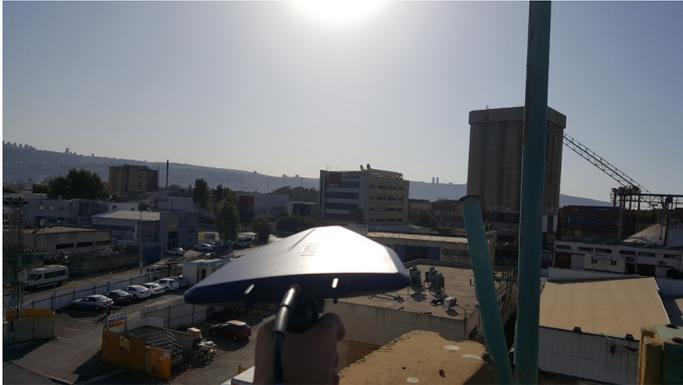
The VIAVI team performed on-site measurement, as the interferer could not be seen from the ground level. From the tower, using VIAVI's log periodic antenna, the team detected a single tone interference at PRB #33 (around -96.25 dBm) from 201° South.

Single-tone interferer affecting LTE services with pre-amp

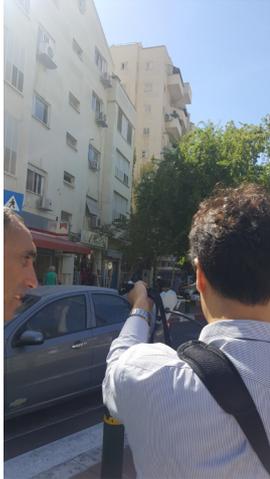
The manual hunt showed that the strongest signal was coming from a TV signal booster on the 9th floor of an apartment building, explaining why it was difficult to detect the signal from the ground.

RF engineer points the antenna at the suspected building
