A Journey Across India to Hunt for Interference with VIAVI CellAdvisor

This case study discusses some of the interference challenges faced by a Tier One mobile operator in India, and how a joint task force of the service provider (SP) and VIAVI engineers was successful in eliminating interference issues at multiple locations using VIAVI CellAdvisor with RFoCPRI and InterferenceAdvisor solutions.

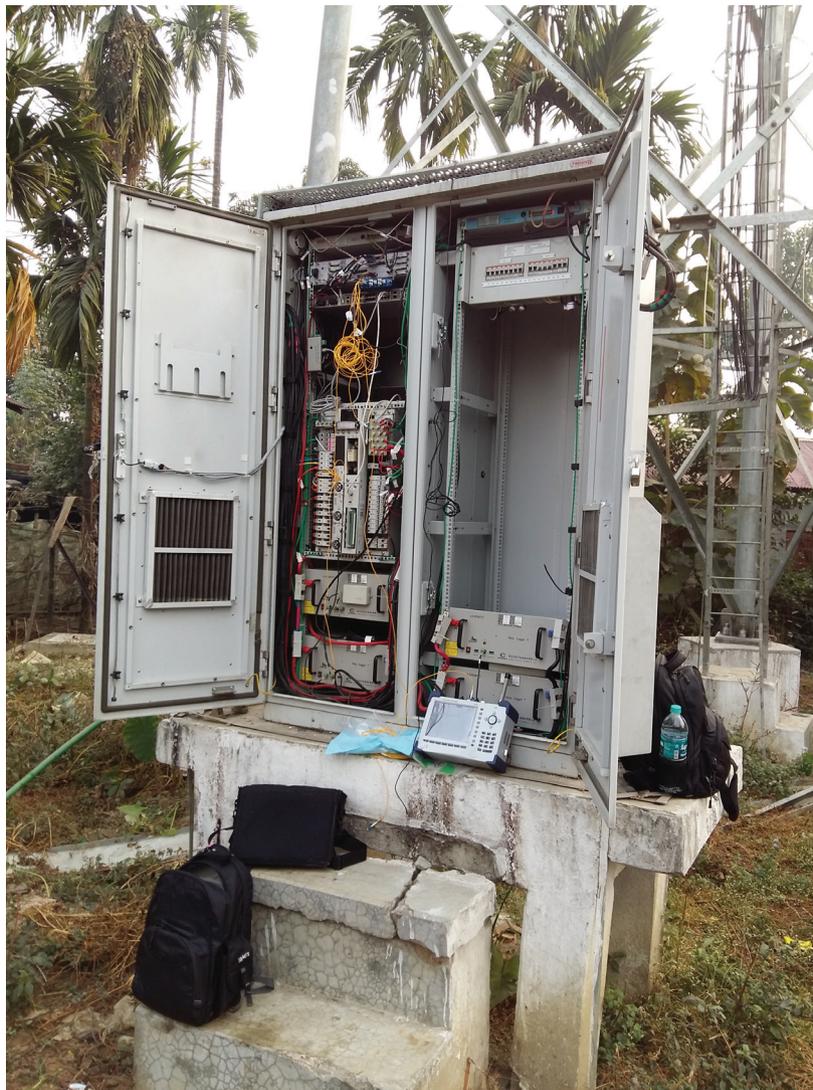
Figure 1: RFoCPRI testing

In January of 2016, the SP was experiencing performance issues in the northeastern region near Siliguri-Naxalbari-Kurseong-Darjeeling sectors. The SP suspected that external interference was degrading VoLTE performance and capacity. It was later identified as a cross-border, 5 MHz WiMAX signal overshooting into the SP's service area, impacting a cluster of sites in that area. (Note that all the affected sites had ground-based towers with antenna centerline present at 50m or higher.) Unfortunately, due to the terrain, interference could not be detected using existing tools, as the interfering signals were not visible at the ground level. VIAVI CellAdvisor with RFoCPRI was able to quickly detect and identify the cause of interference as a 5 MHz WiMAX signal at the BBU location on the ground. CellAdvisor also helped identify some of the key sources of interference in the region like defense radar transmissions and other spurious sources.

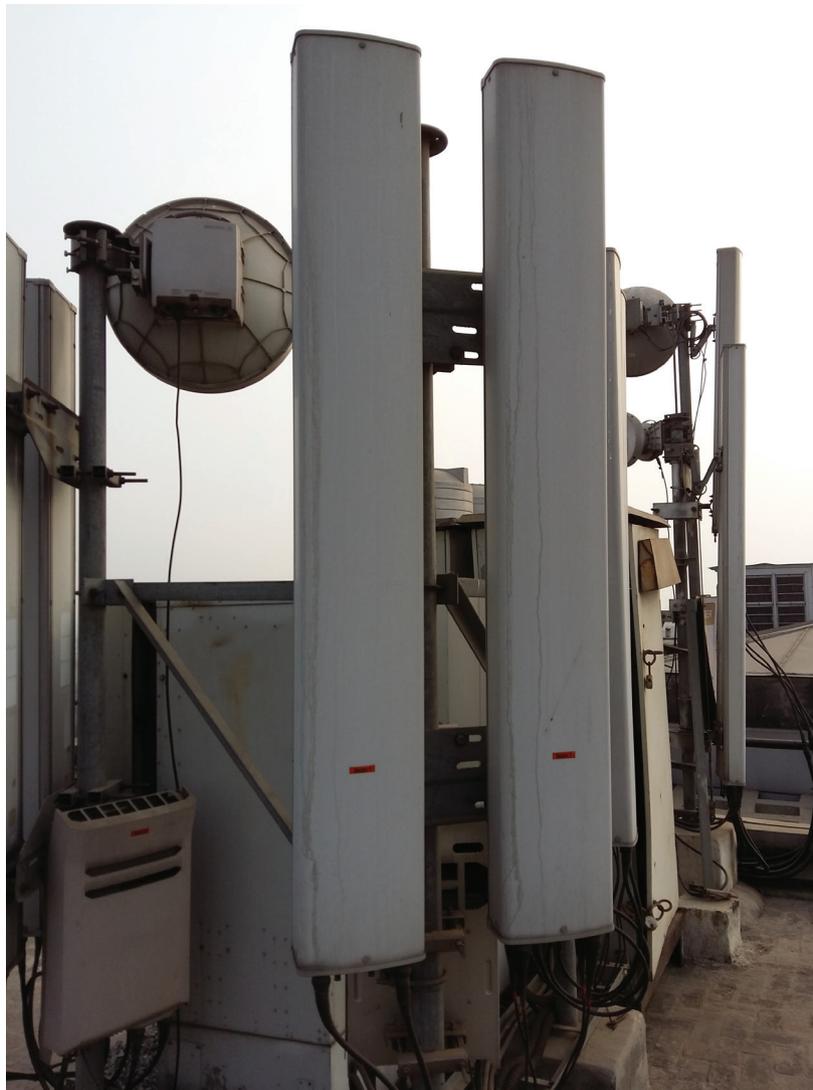
Figure 2: External PIM due to hardware issues caused by cable and antenna system

During the same month, another high-profile interference use case was identified in New Delhi causing high drop calls. VIAVI visited the “Niryat Bhavan” site, where the victim cell site was sharing a location with multiple service providers on a rooftop. After some testing on the rooftop, the team determined that the antenna and transmission line of another service provider was potentially generating intermodulation products, which were causing interference in the FDD Band 3 of the victim service provider. A few months later, the other service provider replaced the antenna and transmission line, and the VIAVI customer was able to confirm that the source of interference was external due to intermodulation signals generated by the other service provider’s faulty equipment. A post-replacement verification visit showed elimination of the interference source; this was also validated at the OSS by reviewing the RSSI stats.

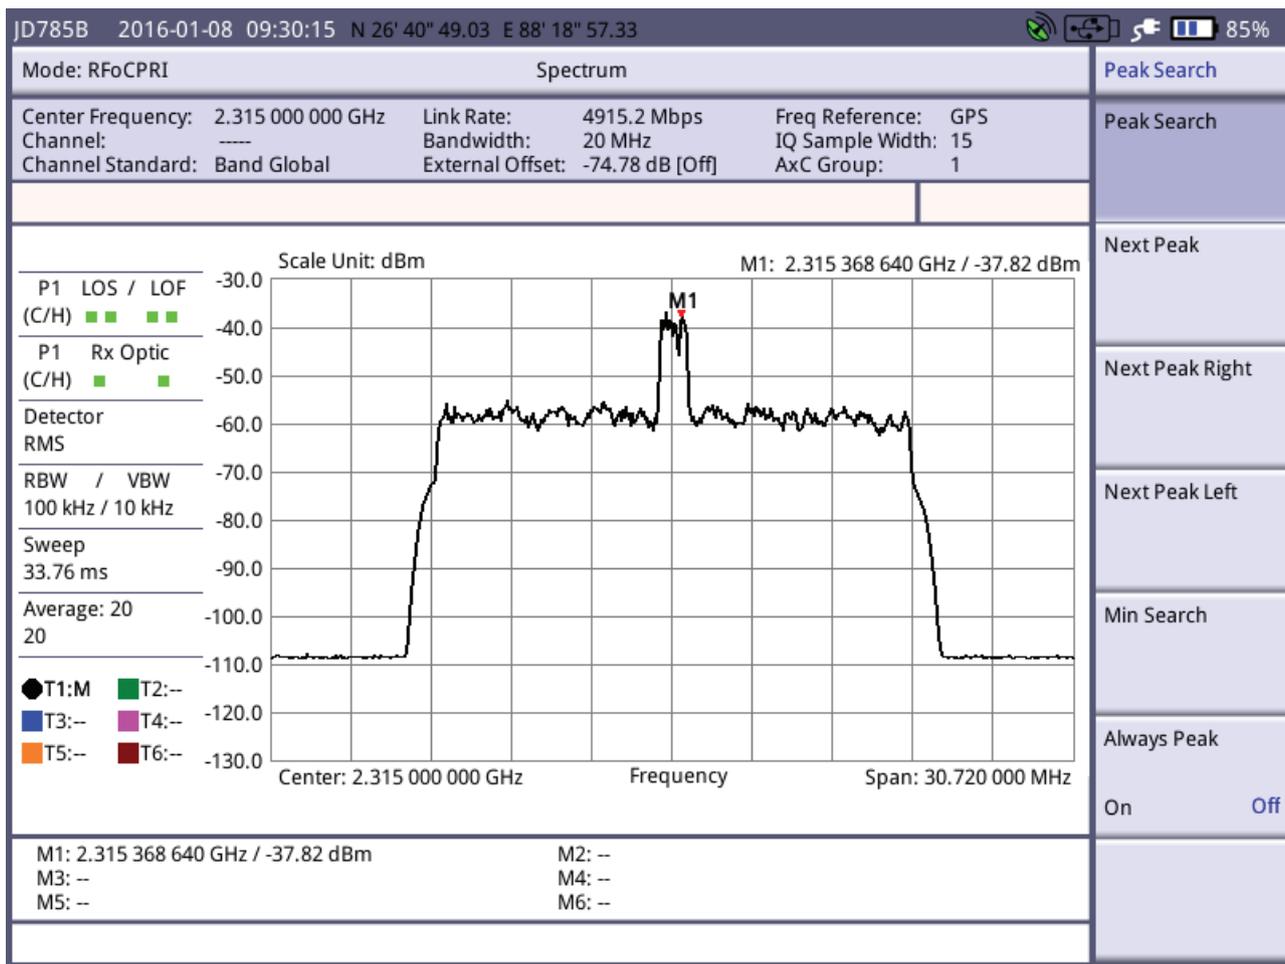
Figure 3: Interference observed by CellAdvisor

The SP approached VIAVI for help identifying multiple RF performance issues in Bengaluru in August of 2016. The team suspected some form of interference impacting the cell-site performance. After testing with CellAdvisor with RFoCPRI, the team identified another case of interference caused by intermodulation; after quickly identifying the root cause of the performance degradation, the problem was resolved.

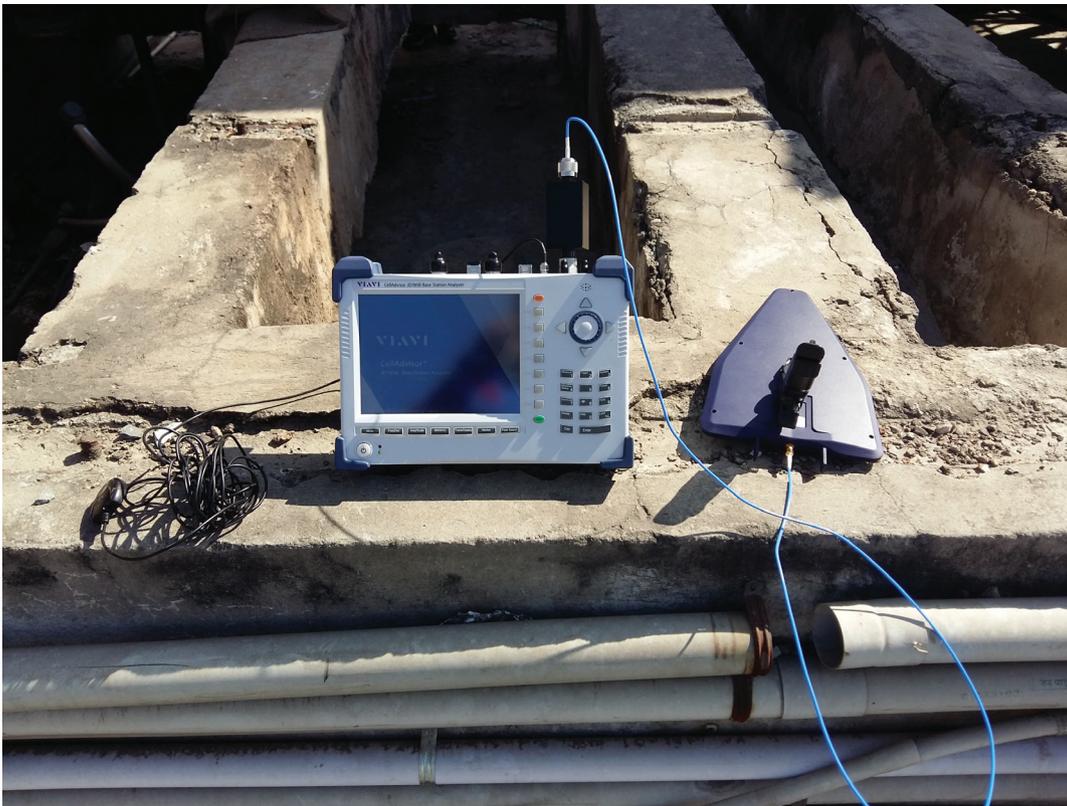
Figure 4: AntennaAdvisor used to identify interference source

During the same time frame, the service provider observed spurious signals generated by a security system that were responsible for increasing the RF noise floor, causing performance degradation. This was a tricky scenario, as identifying a source of interference takes a long time and a lot of RF expertise. However, with the help of the VIAVI InterferenceAdvisor solution, the team was quickly able to isolate and locate the source of interference. InterferenceAdvisor is the VIAVI best-in-class interference locating solution, enabling one engineer to quickly and easily identify an interference source, even in urban environments. Unlike other solutions in the industry, it is fully automated and offers interference area indication, with voice prompts and navigation guidance. InterferenceAdvisor not only saved time in isolating and locating the interference source, it also provided visibility previously unavailable to field engineers.

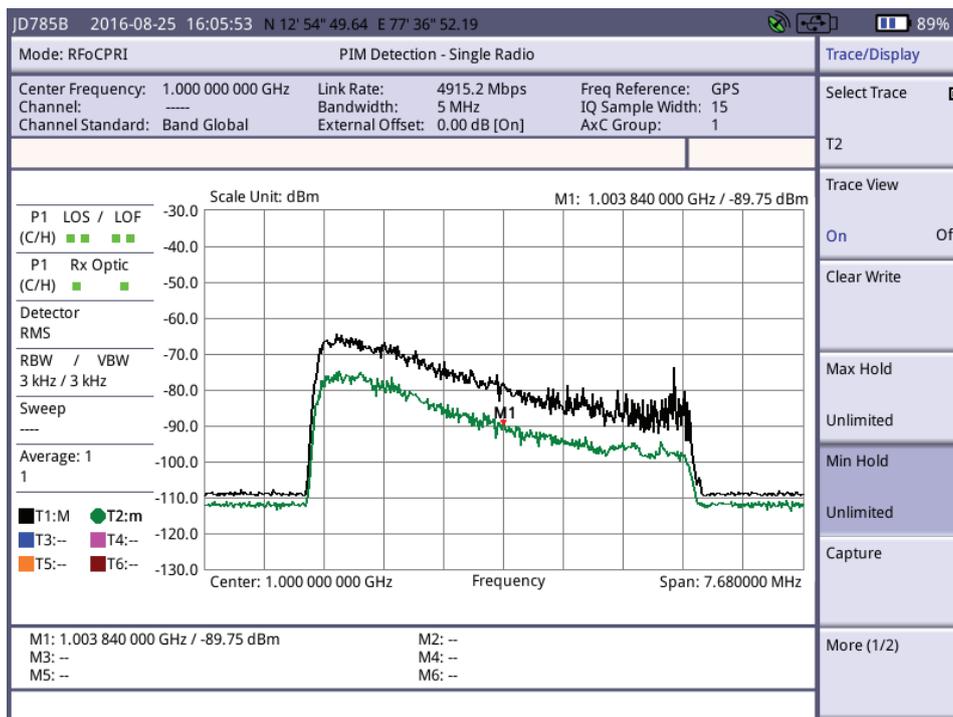
Figure 5: PIM observed by CellAdvisor

In May of 2017, the SP asked VIAVI for help to evaluate 850/1800 MHz and 2300 MHz band sites for interference. The service provider's teams were having difficulty identifying the root cause of the interference issue. VIAVI and the SP's field team visited four sites in Ahmedabad and Surat and identified that internal Passive Intermodulation (PIM) from the radio transceiver path as the cause. The problem was later rectified by replacing fiber and jumper cables. Interestingly, the 850 MHz and 2300 MHz band sites were reporting high RSSI while there were no external sources of interference, so it was assumed to be a case of intercell interference. The issue was reported to radio equipment vendor for resolution.

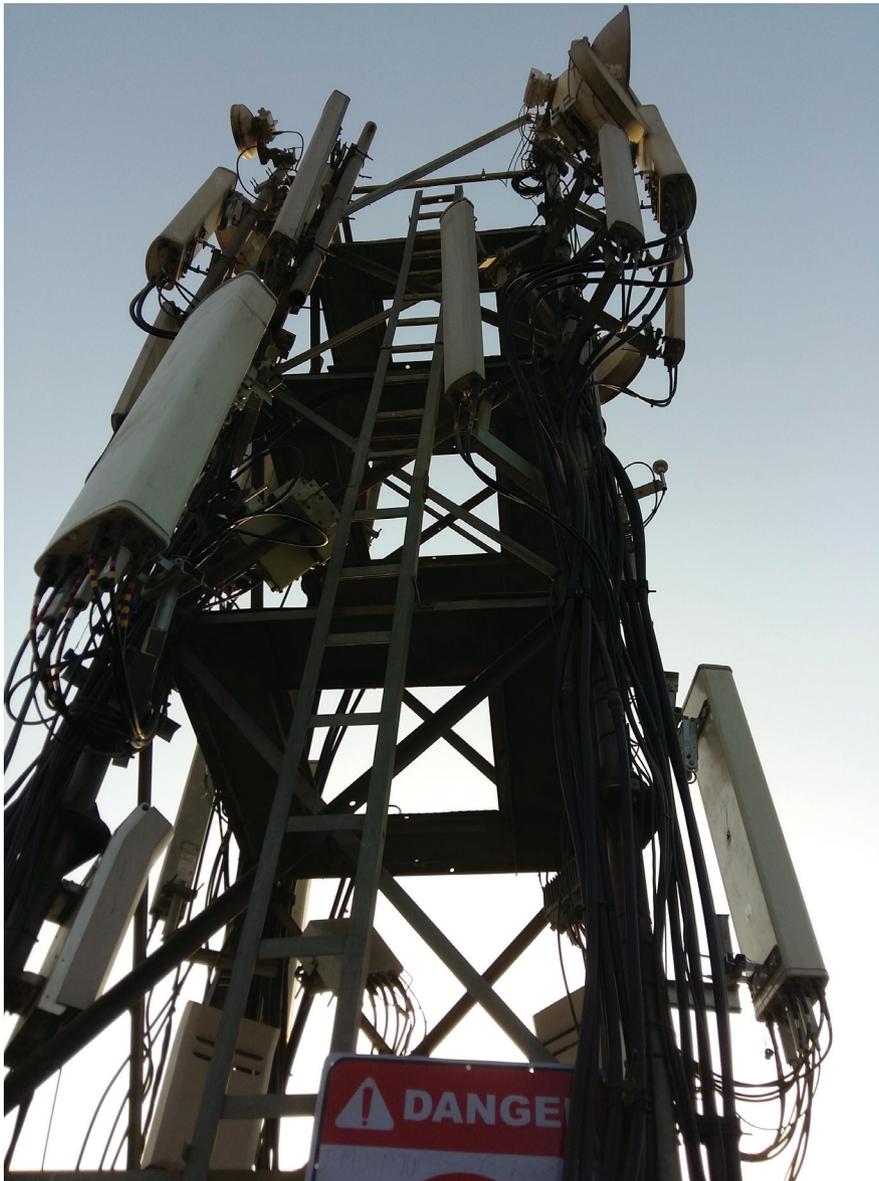
Figure 6: Close proximity of antenna co-location

In May of 2017, in another unique case of interference hunting, the service provider invited VIAVI to help troubleshoot a performance degradation issue in the northeast section of Arunachal Pradesh. The SP team suspected the interference was caused by another service provider's signal transmission into their TDD band. With the help of CellAdvisor Base Station Analyzer with RFoCPRI, the team was able to identify 'Close Coupling' between the two service provider antennas as the cause. Specifically, there was improper spatial distance between the two services service antennas, causing high RSSI at the cell site. The team also observed that such cases would exist any time there are small guard bands assigned between two radio transceiver systems, as these two issues can cause high coupling factor. At yet another site, the VIAVI team observed a closely placed small cell raising the noise floor of the affected macro cell. RSSI stats improved when the small cell was turned off.
